TEAC **TECHNICAL INFORMATION**

RW-800/CD-RW700/CD-RW2000, Change of Capacitor

No. **0206**
DATE 31st May 2002

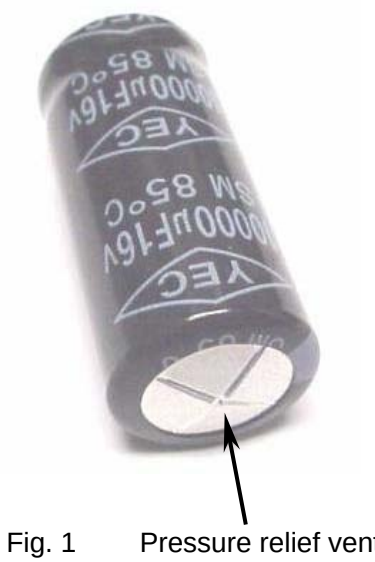
Fig. 1 Pressure relief vent

Additional Information
1. It has been reported that "pressure relief vent" of the defective C07 would open like Fig. 1.
2. C07 is fixed by an adhesive bond. This looks like a "leak" but not. See Fig. 2.

Symptom: Various. No display, Suddenly stops, does not boot and so on.
Cause: Defective C07 (Electrolytic Capacitor, 10000µF/16V) on the AUDIO/POWER PCB Assy.
Product quality of the capacitor seems to be low.
Remedy: C07 capacitor has been changed to another manufacturer's one as follows:

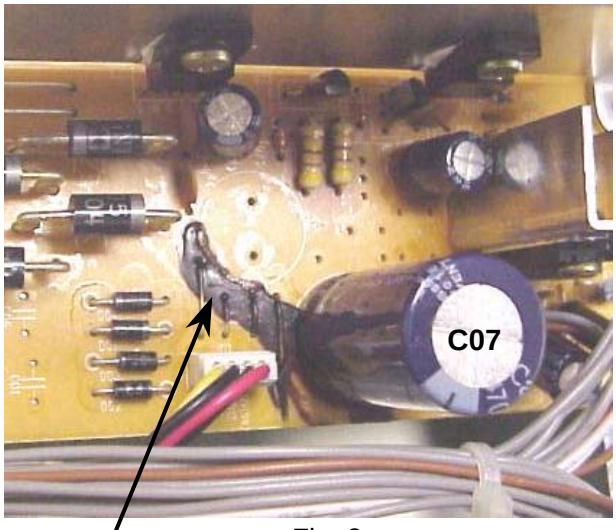
Fig. 2
This is not a leak but an adhesive bond.
