TEAC

TECHNICAL INFORMATION

No. 0714

TASCAM CD-RW900/901, Low Temperature Boot up

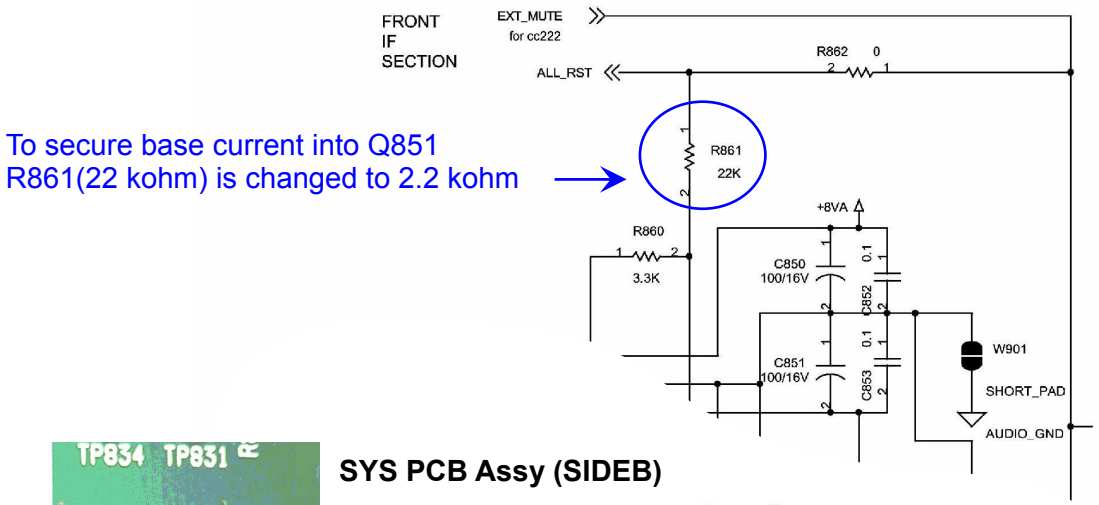
SCHEMATIC DIAGRAM CD-RW900/901 SYS(1/3): AUDIO SECTION

To maintain safer wake up of Q820/920 on Sys (1/3) SCH (C, 7), Power on Mute Trs even under lower temperature environment, the following change has been made on the products with the following:

Symptom: No output or noise on outputs has occurred during several minutes after powering on the unit made at the first attempt in rather cold morning.
Cause: A value of R861 in PDOWN signal pass has been selected to cause a lack of Q851 base current.
Solution: R861 (22 kohm) on Sys(1/3) SCH (D, 2) has been changed to 2.2 kohm.

Old	New
R0156964 RD,1/10W 22 KOHM G	R0156724RD,1/10W 2.2 KOHM G
